**THE JONES LIBRARY**  
**AMHERST, MASSACHUSETTS**  
**HISTORIC STRUCTURE REPORT**

**DRAFT 12-22-21**

Prepared for:  
The Town of Amherst  
Amherst, MA

DECEMBER 22, 2021

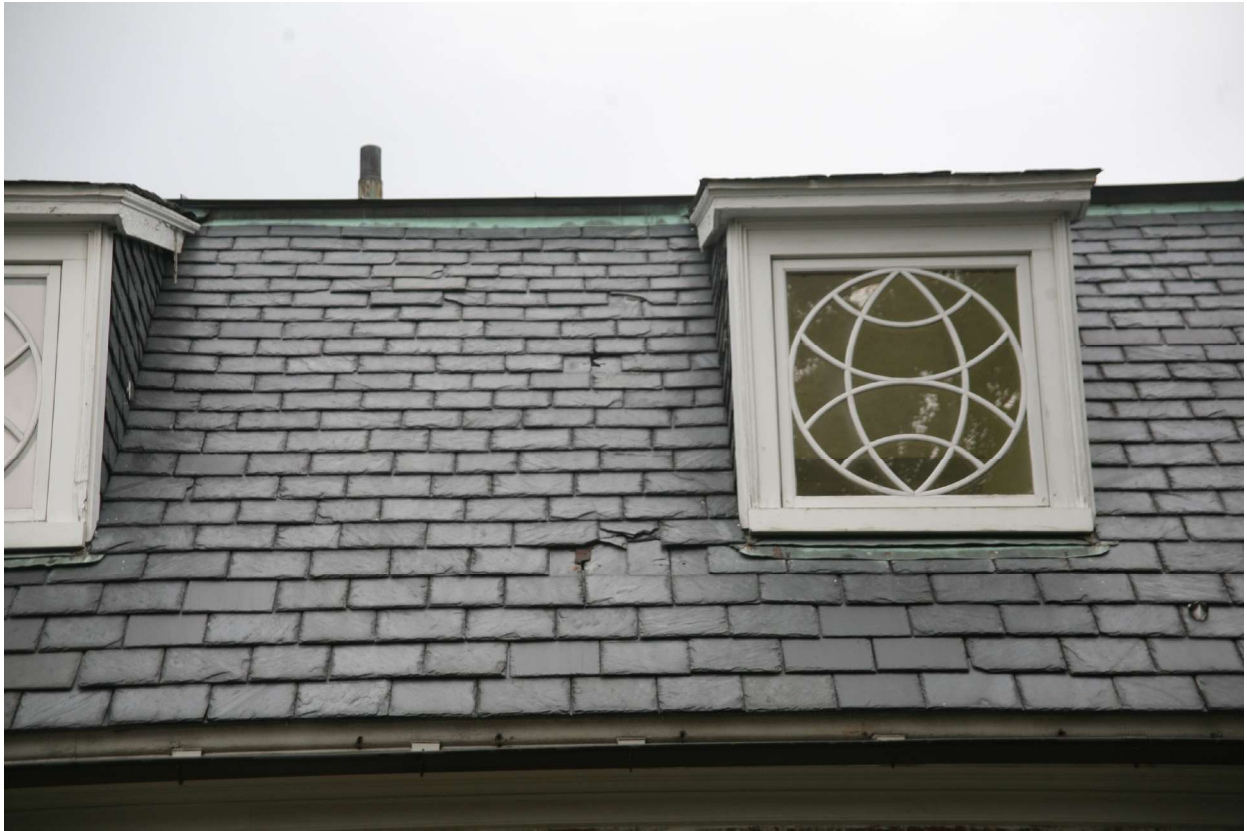
*Fig. 5500. The dormers on the east side of the library are treated with decorative tracery that helps to break up the glazing in the opening. This window design shows up in the Kirstein Business Branch of the Boston Public Library designed by Putnam and Cox in 1930. Note the missing slates and condition of the roof in general.i*

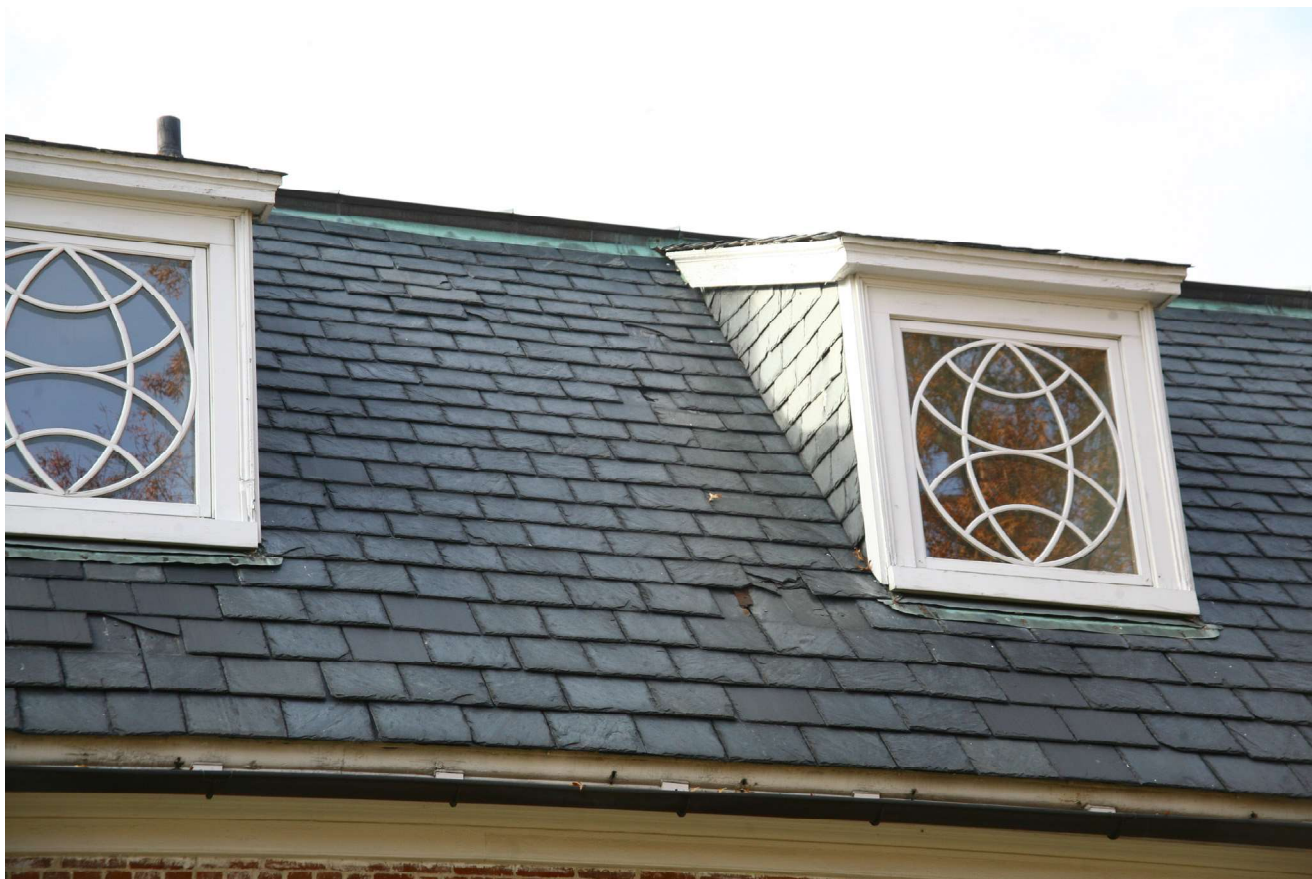
The majority of the slate roof appears to be original and is at the end of its service life (Fig. 5600). The roof exhibits numerous problems typical of slate roofs of this age and design. It appears to have been well maintained over the decades; however, as with all forms of roofing, it is at a point where the roofing system needs to be removed and replaced in-kind with a new slate roof matching the original design.

- Broken slates missing their exposure/margin ;
- Cracked slates partially remaining;
- Ill fitting replacement slates;
- Old repairs that have since failed;

*Fig. 5600. East wing. Detail of slate roof. Multiple missing and broken slates. The conditions here are representative of what is seen elsewhere across the roof.*

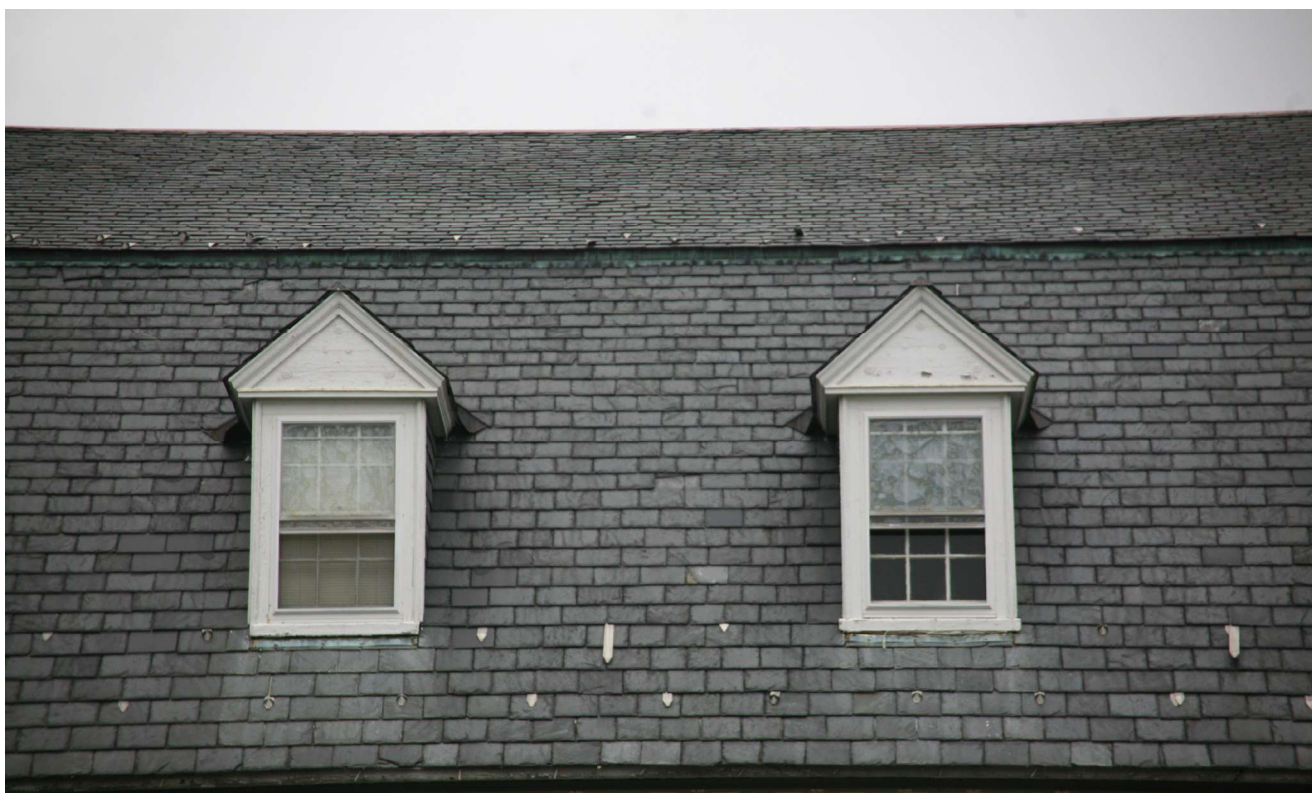
*Fig. 5463. The slate roof was laid with a graduated exposure, so the lower slates show more of their surface to the weather than those nearer the curb (where the pitch of the roof changes). Notice the snow guards that have slipped and random broken slates.*

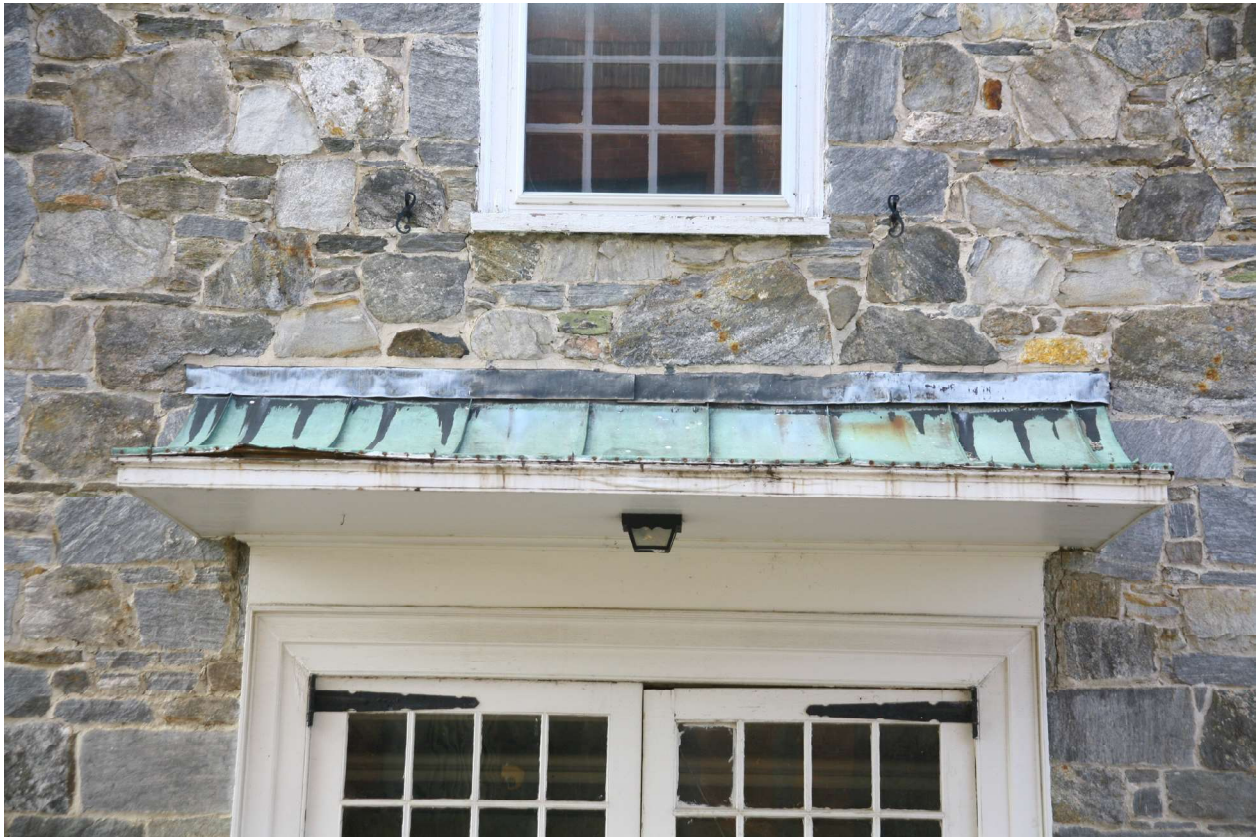
Like the slate roof, the standing seam copper roof over the double doors on the east side of the ell is at the end of its service life and should be replaced in-kind (Fig. 5611). While the surface of the copper roof was not observable, a section of it along the eave edge has pulled up and the head flashing where it meets the masonry side wall has been replaced in the recent past

*Fig. 5611. Copper roof at east barn doors. The roof is lifting away at the left end and is generally in poor condition. It has served its purpose and is at the end of its useful life. This roof should be replaced in-kind with new, standing seam copper roofing.*

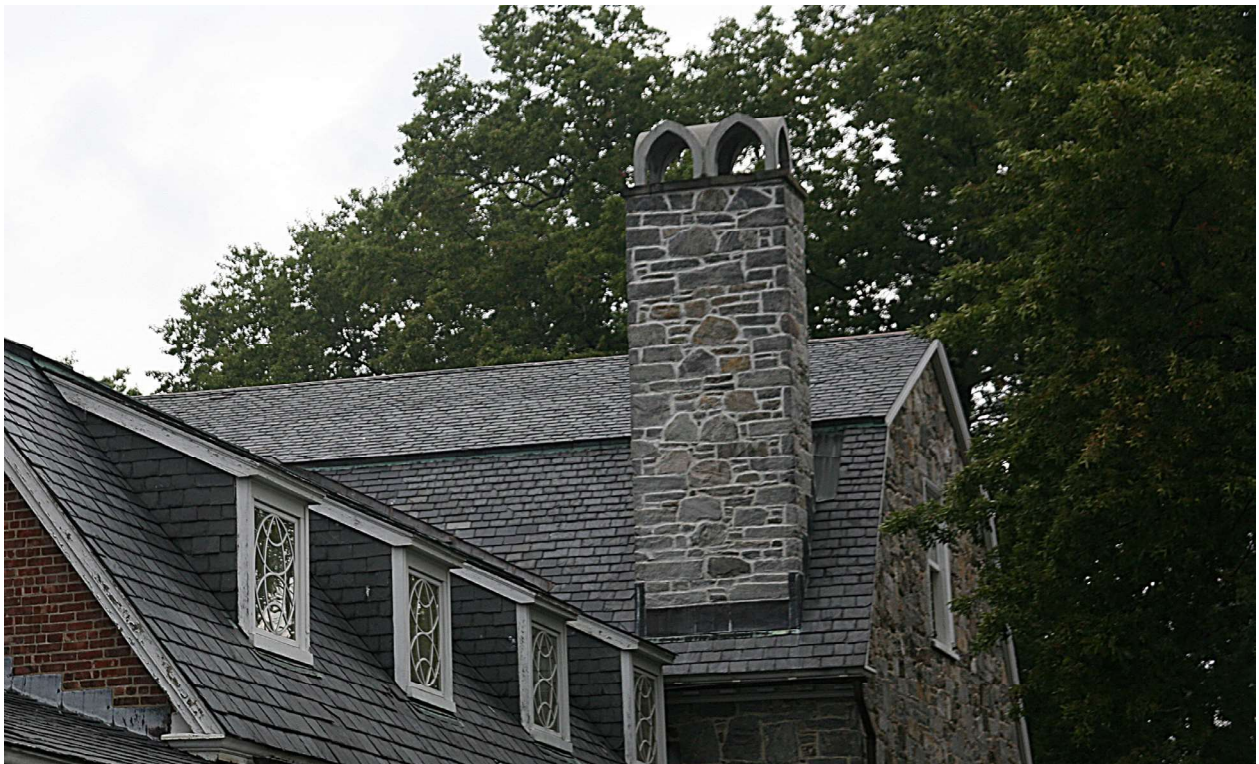
*Fig. 5488\_crop. Northeast chimney. The modern mortar used to point the chimneys lacks the variety of color and texture found in the original mortar. As a consequence, even set high up on the building, it stands out given its uniform gray appearance.*

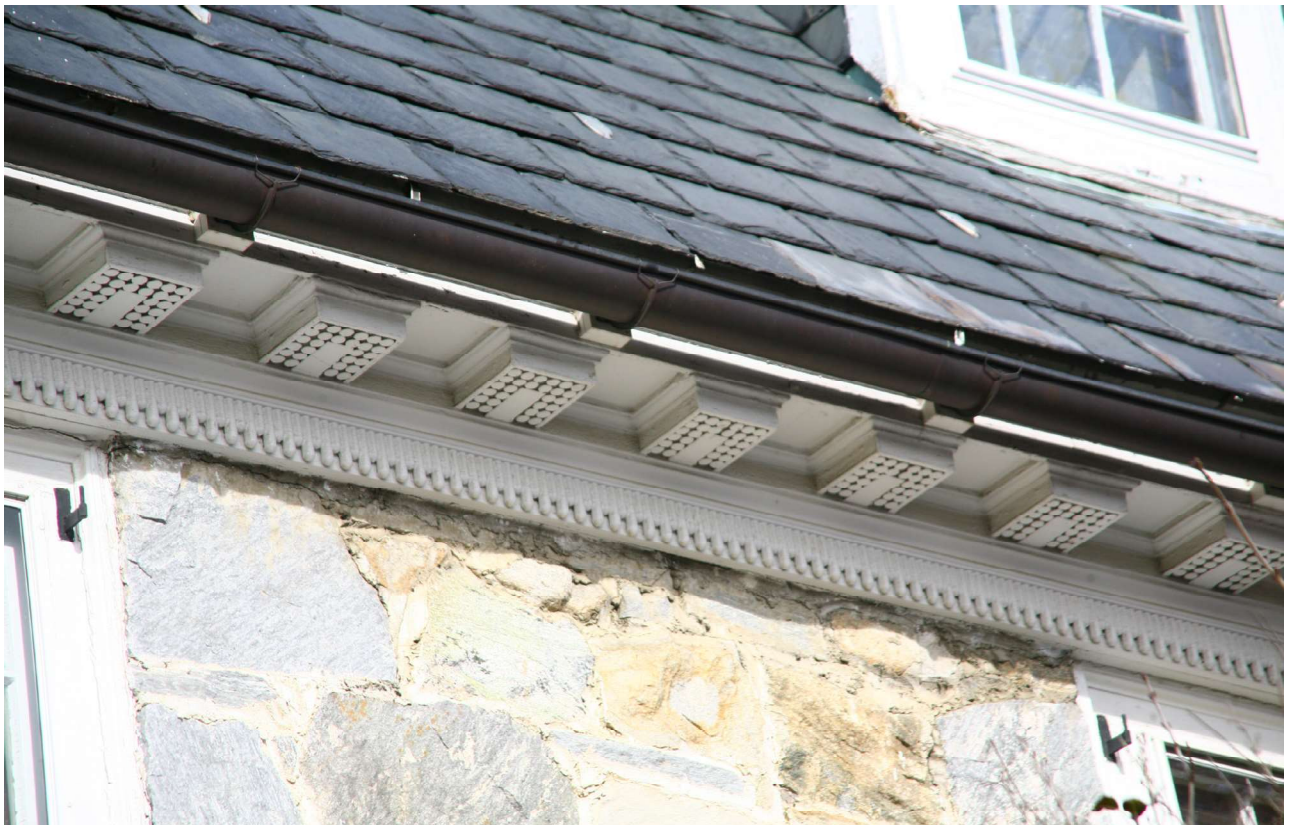
The center block of the library has a deep, decorative wood cornice modeled after those found on fashionable, late-eighteenth century dwellings (Fig. 5552). These types of cornices were originally inspired by designs published in architecture books by Asher Benjamin. Benjamin, who is attributed with publishing the first American architectural treatise, lived in Greenfield, Massachusetts and published his first book, *The Country Builder's Assistant* (1797) there as well. While such a cornice may simply be present owing to the building's colonial precedent, one can only wonder if it was a conscious nod to Benjamin by architect Allen Cox, who most certainly would have been aware of Benjamin's work.

The cornices appear to be in good condition and only suffer from failing and peeling paint. They should be prepped and painted to prevent any decay of the woodwork.

*Fig. 5552. Detail of the decorative wood cornice found on the building. Note the half round copper gutter in front of the cornice and shutter hardware at the window openings.*

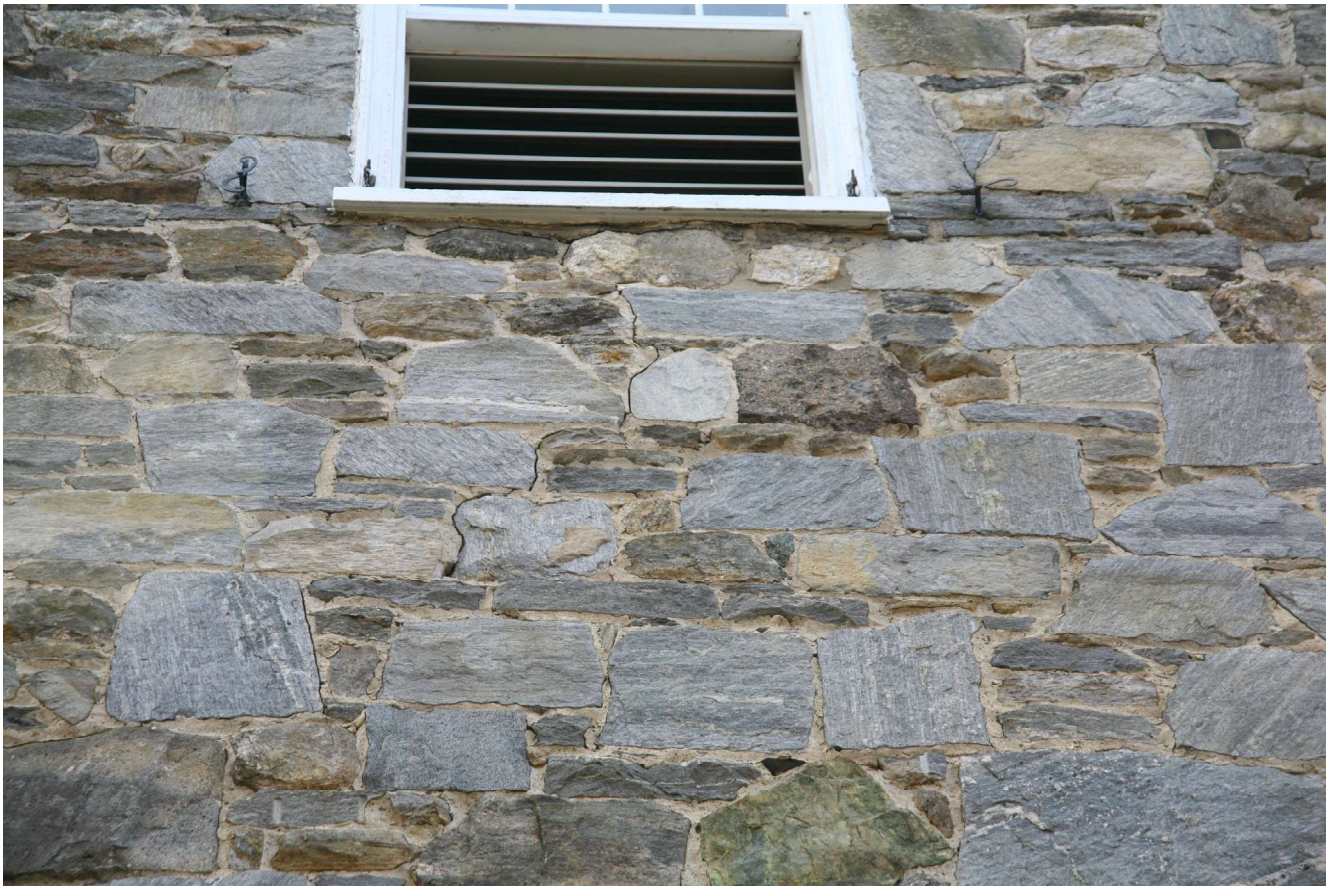
A couple of tight, yet long vertical cracks are visible on the east wall of the northernmost portion of the ell where the auditorium was originally located (Fig. 5633, 5632). The exact cause of these are not known; however, given the amount of changes and alterations made to this location, they may relate to structural alterations performed here. Tie rods on the north end of the building here suggest reinforcement has been made to

*Fig. 5633. East elevation of the east wing at the north end. Note the vertical crack running up the center of the image.*

the walls some time in the past. These cracks should be examined by a professional engineer to determine their cause and status.

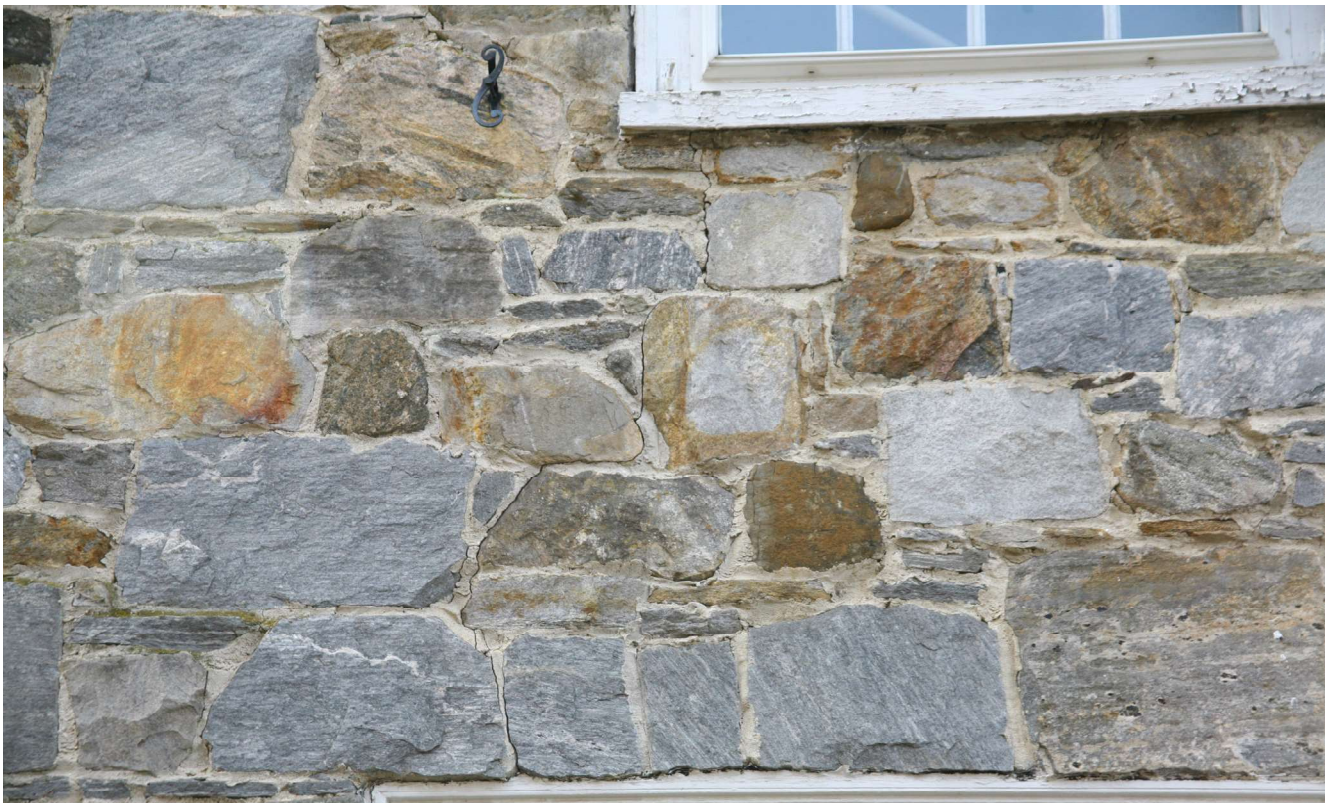
*Fig. 5632. Same location as previous image. This is a continuation of the crack seen in the previous image.*

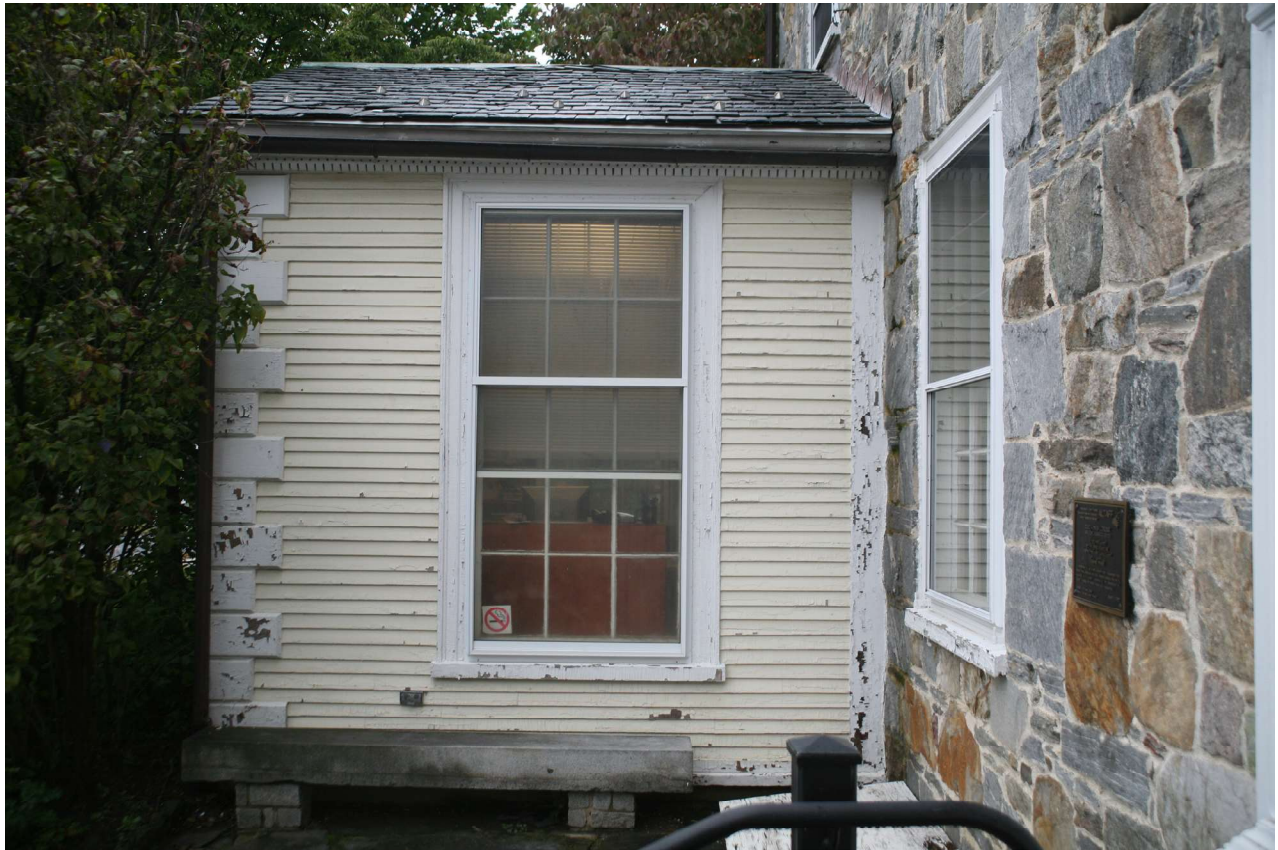
are in good shape. The greatest issue plaguing them is failing paint (Fig. 5471). Both need a proper paint job, including scraping, prep, prime and top coats of a high quality paint finish. Paint analysis should be done to determine the original color prior to repainting the building. Like the rest of the building, the slate roofs are also at the end of their service life and should be replaced.

*Fig. 5471. West Sun Porch, east elevation. Like much of the woodwork on the building, the paint on the Sun Porches is in poor condition. All of the painted surfaces need to be prepped and refinished with a high quality paint system that includes priming areas of bare wood along with two top coats of finish paint.*

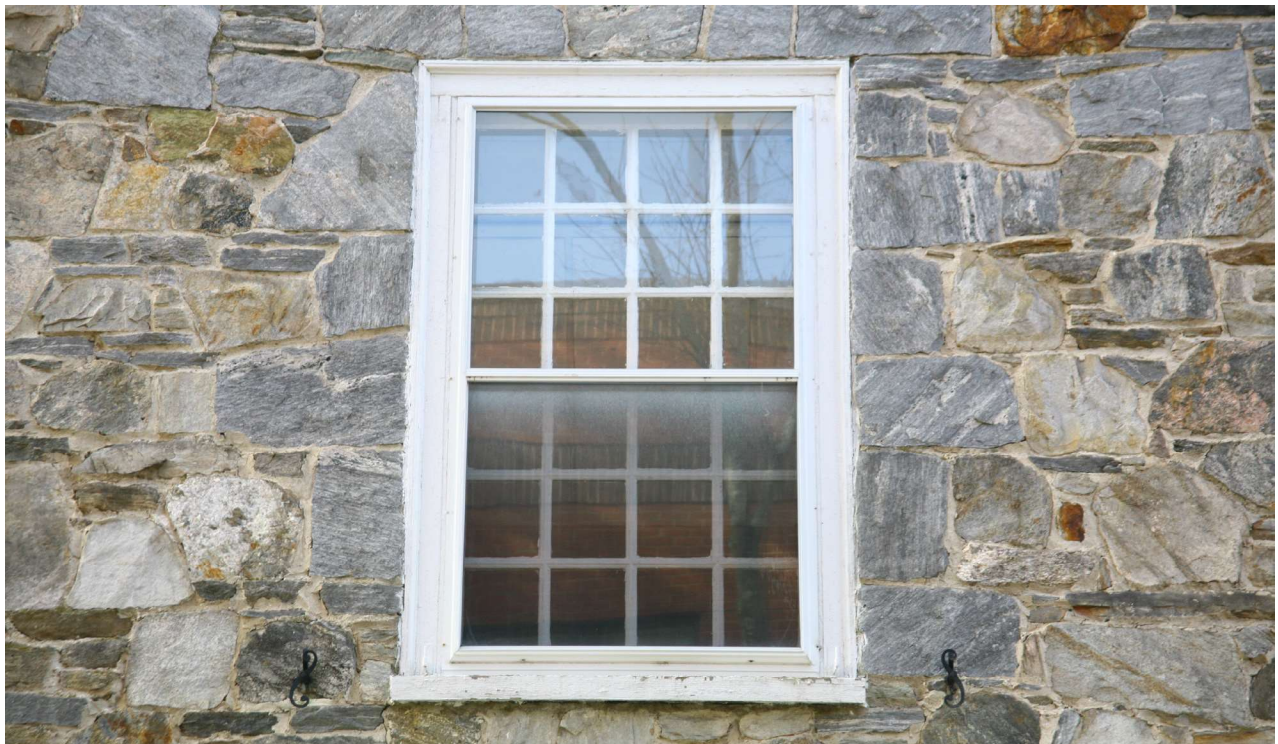
The library’s fenestration consists of divided light windows in a variety of configurations. The south elevation of the main building employs traditionally proportioned 12/12 wood, double hung sash windows (Fig. 5610). Louvered wood shutters, now missing, originally flanked these openings. In the Sun Porches, large, double-hung sash (6/9 and 5/15) are located in the three elevations, providing the spaces with as much natural light as possible. Elsewhere, where the design permitted, large fixed windows were placed to illuminate spaces.

*Fig. 5610. Typical 12/12 divided light wood window found in the building. The wood windows are character defining features of the building and should be repaired and retained throughout. The existing storm windows are at the end of their service life and should be replaced with a high quality, low profile storm window. Notice the holdbacks mounted in the masonry at the bottom of the window for the shutters.*

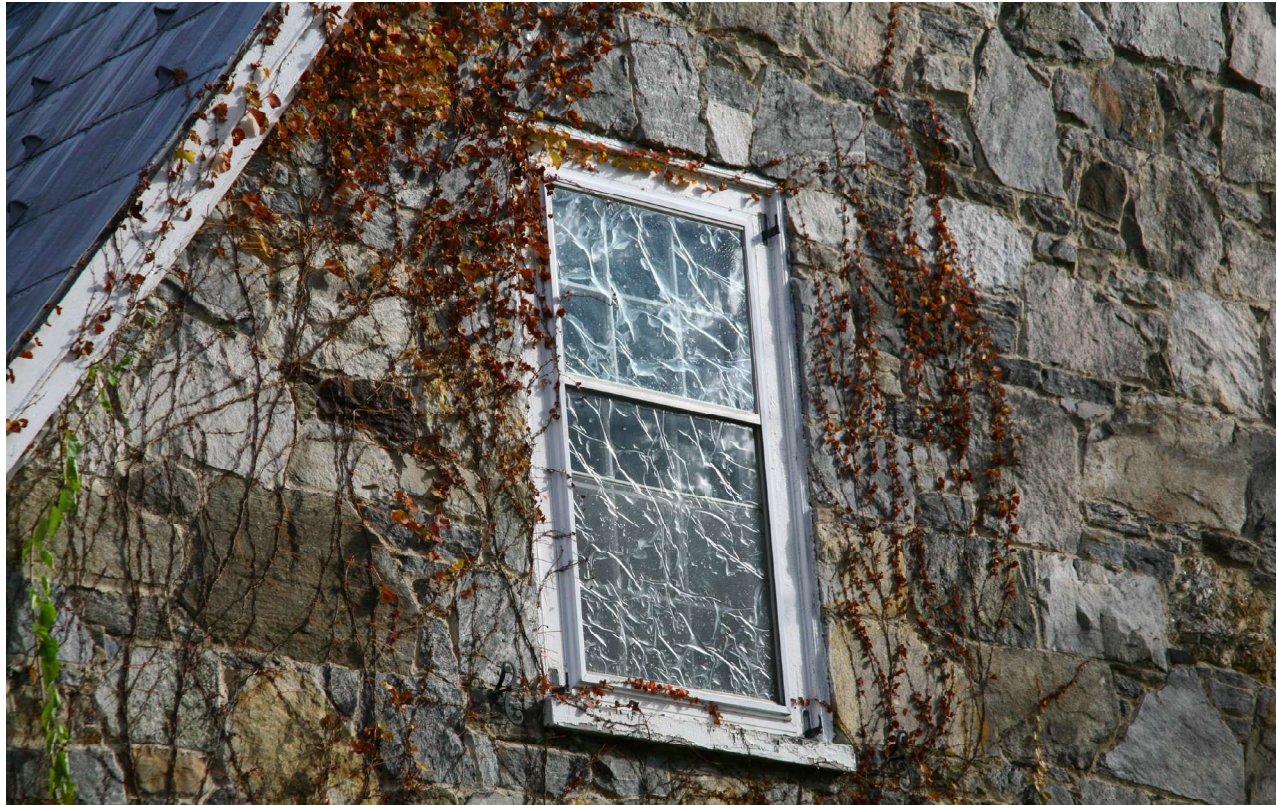
*Fig. 5661. Many of the storm windows on the third floor of the library have had UV protective film applied to them. The film is well past its service life and is now bubbling and peeling from the surface of the glazing. Owing to the age and quality of the storm windows, it makes most sense to replace them with a high quality, low profile storm window system.*

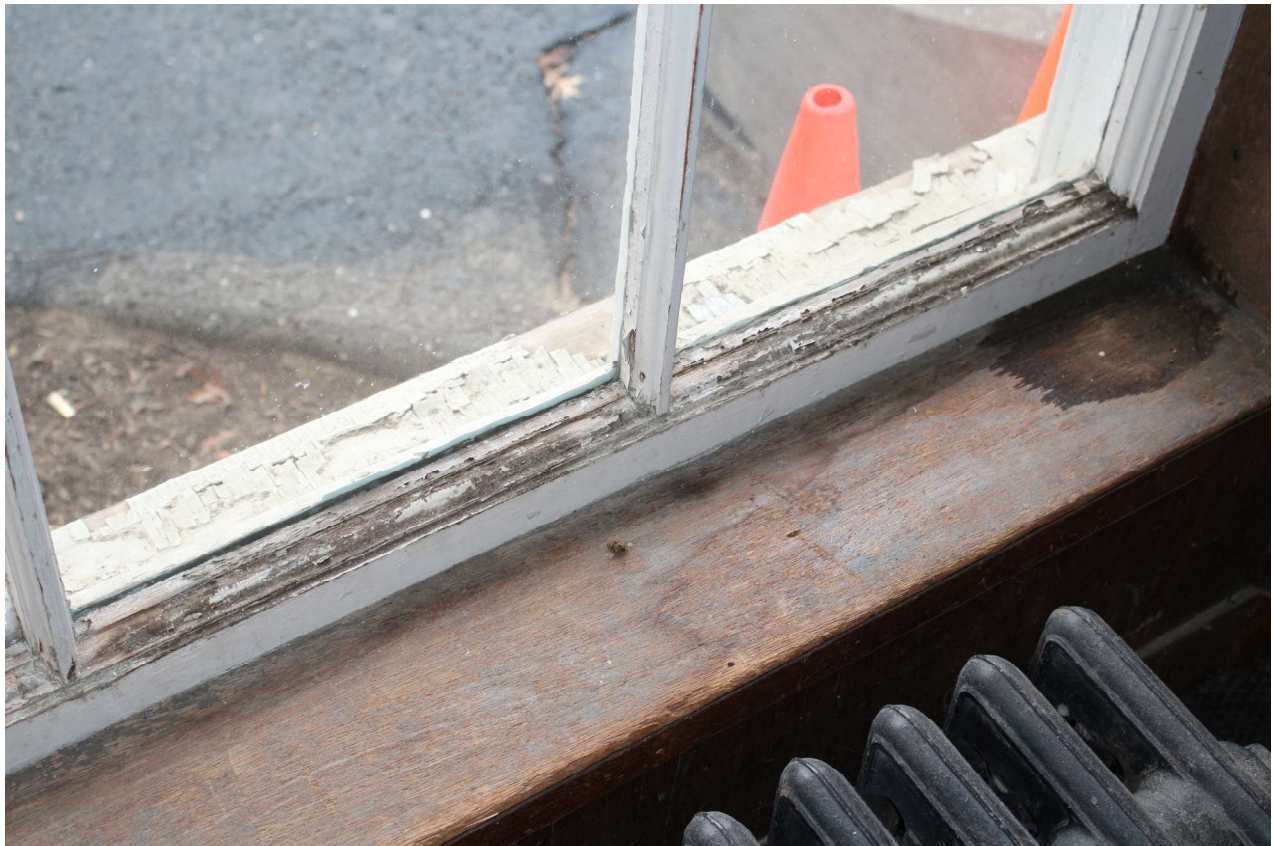
*Fig. 8703. Representative examples of failing paint on the window sash and water stained sills. These conditions are typically the product of condensation that forms on the window glazing and eventually drips down onto the sash and sills. The sill also looks to be dried out due to failure of its clear coat and decades of UV exposure.*

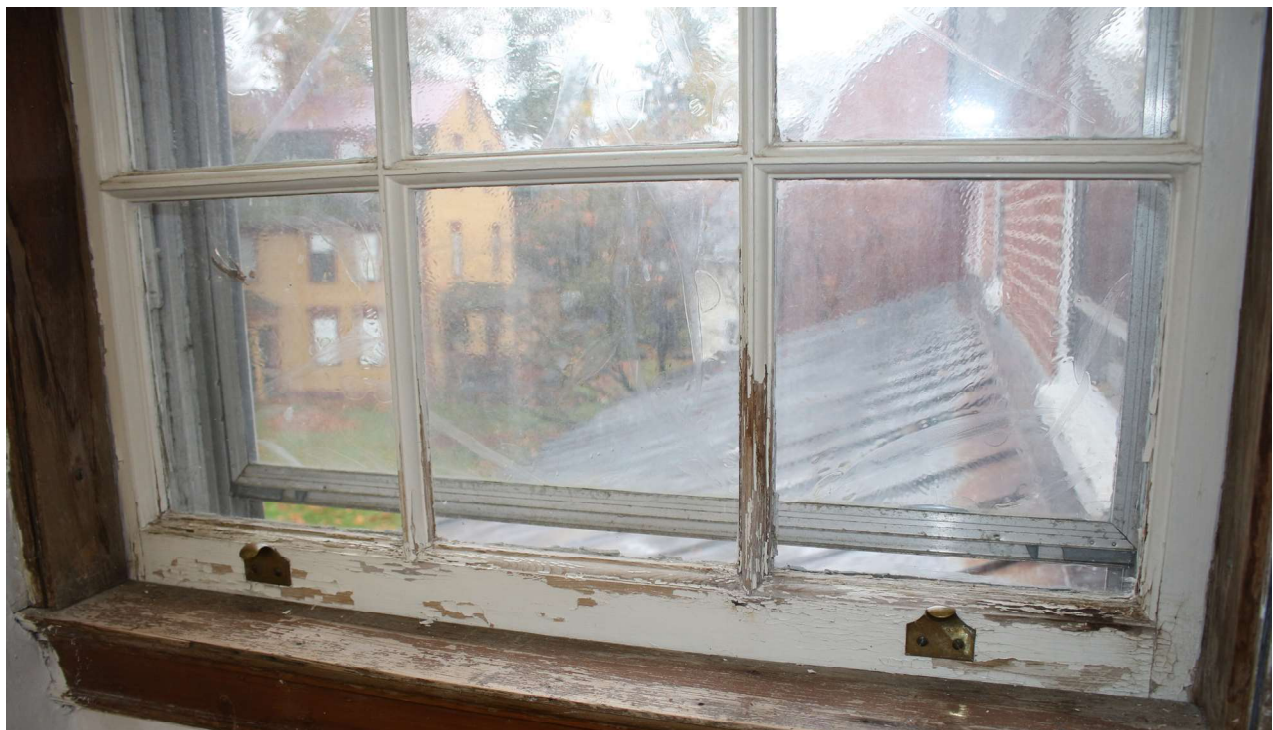
*Fig. 8792. West wing, second floor north window. This window exhibits the typical failures seen from condensation and UV damage. The window is situated in what appears to be a problematic location, where the upper roof discharges rain and snow onto the lower roof seen through the window. Being the north side of the building, it likely holds moisture and snow longer than elevations that receive direct sunlight.*

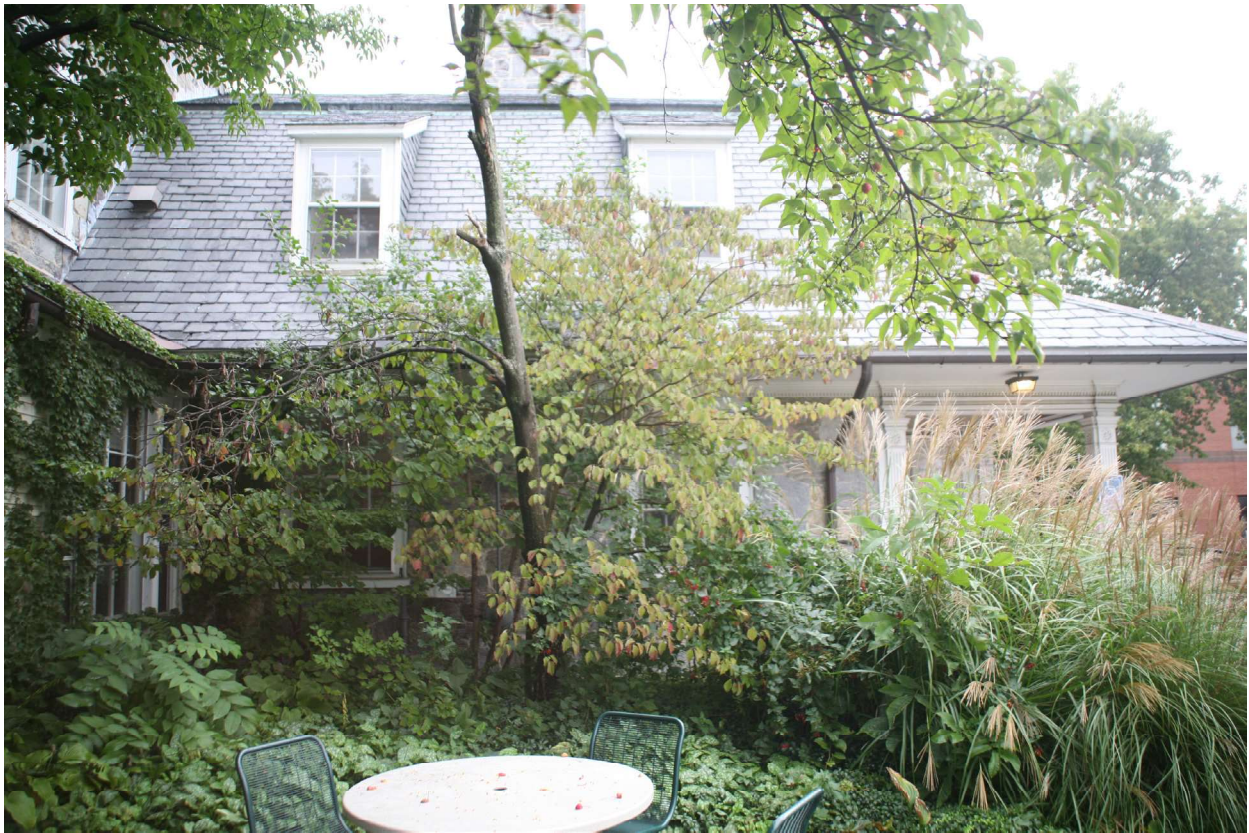
The landscape immediately surrounding the library is heavily planted and includes a number of large trees in close proximity to the building (Fig. 5492 + 5521). The current state of the landscape presents a number of issues. The amount, type, and density of the surrounding plantings obscures the majority of the building's primary elevation while they are covered in leaves. In addition to hiding the building, this condition prevents natural light from entering the building and, more detrimental, slows moisture trapped around the perimeter of the building from drying after storms. This latter condition encourages situations such as mold and mildew growth on the building and accelerates the deterioration of paint finishes. Ideally, the number of large deciduous trees in close proximity to the library should be kept to a minimum. In addition to the aforementioned issues, large trees risk damaging the building in the event severe storms cause limbs to break or trees to uproot. If plantings around the perimeter of the building are desired, they should be kept to low shrubs and/or ground cover plantings with a two to three foot buffer between them and the building for future growth and maintenance.

*Fig. 5492. East entry. The building is hidden behind a variety of different plantings that range in size and type. Vines should not be allowed to grow on wood surfaces. Large deciduous trees should be removed and kept well away from the perimeter of the building*

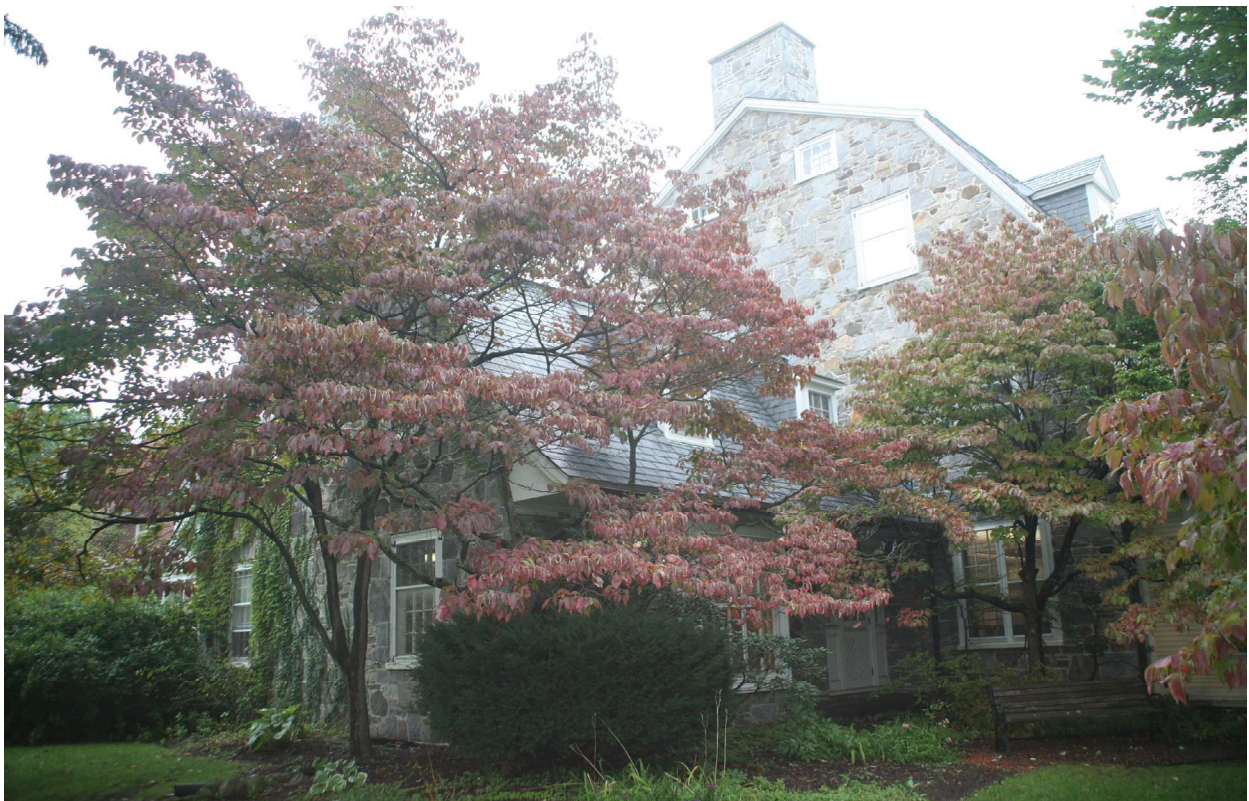
*Fig. 5521. West entry. Like the east entry, the west wing is also surrounded by close plantings that hide the building's*

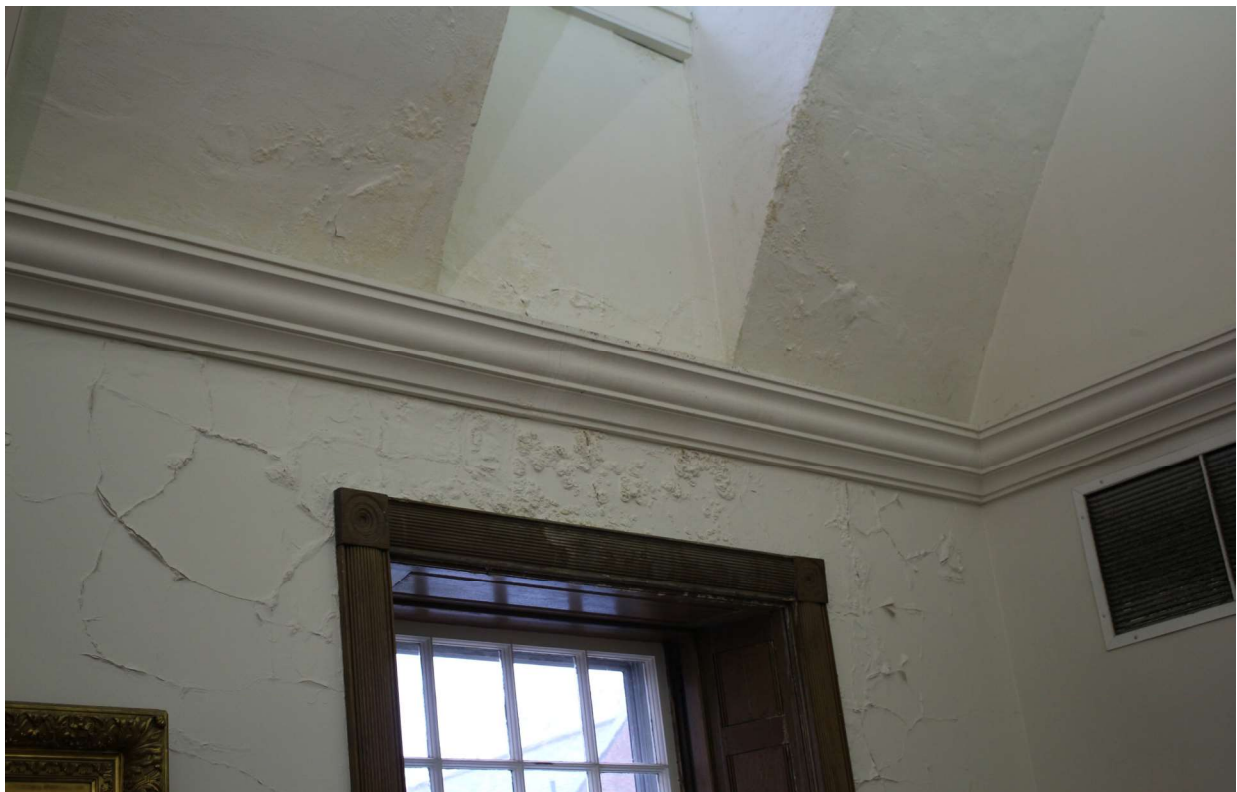
*Fig. 8813. Southeast corner of the former auditorium. Past water infiltration has caused the gypsum plaster finish to bubble and deteriorate. This inturn has caused the paint finish to fail as well. This is representative of the plaster surrounding many of the dormers and is likely the result of roofing issues.*

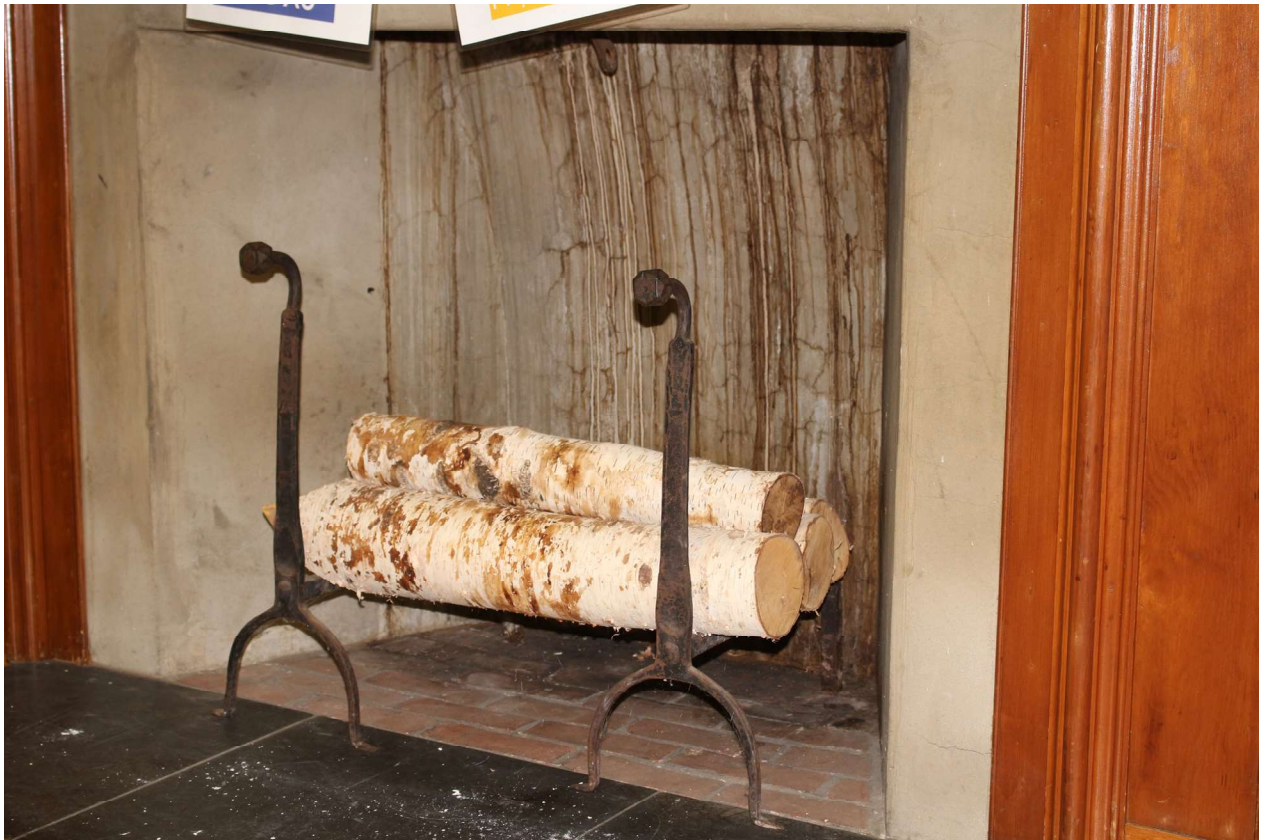
*Fig. 8797. West wing, second floor fireplace. Note water stains in the firebox and rear of the hearth. The white debris on the forehearth is paint and plaster dust from the ceiling above. This location should be monitored to determine the status of water infiltration. The chimney here should be capped if it is not already.*

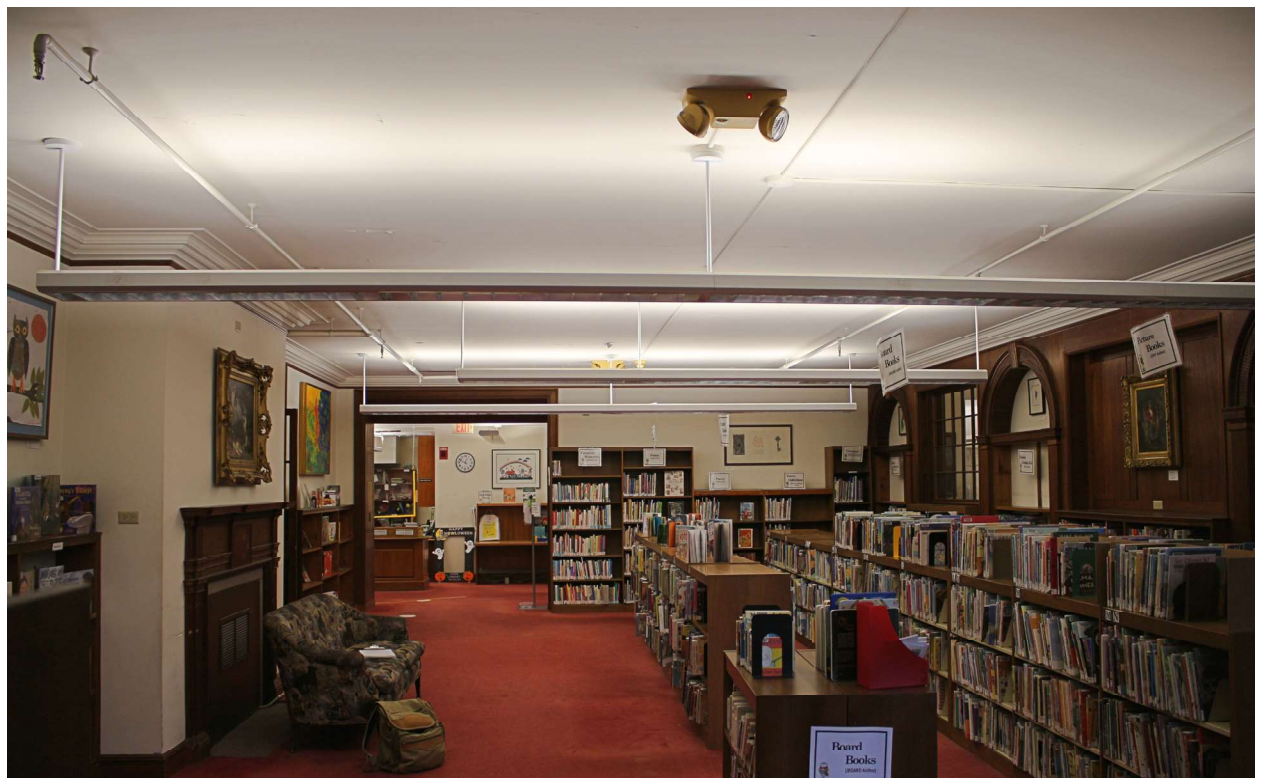
*Fig. 8768. Children's stacks. This representative example of incremental change shows how the introduction of things like modern lighting, fire detection and suppression systems, emergency lighting, mechanical systems in the fireplace and modern paint colors and carpeting has radically changed the original architectural design and feeling of the space.*
